THE SUTTON HISTORICAL SOCIETY

— BULLETIN —

VOL. XIX NO. 3 OCTOBER 1990

EIGHT LOTS SCHOOL REPORT

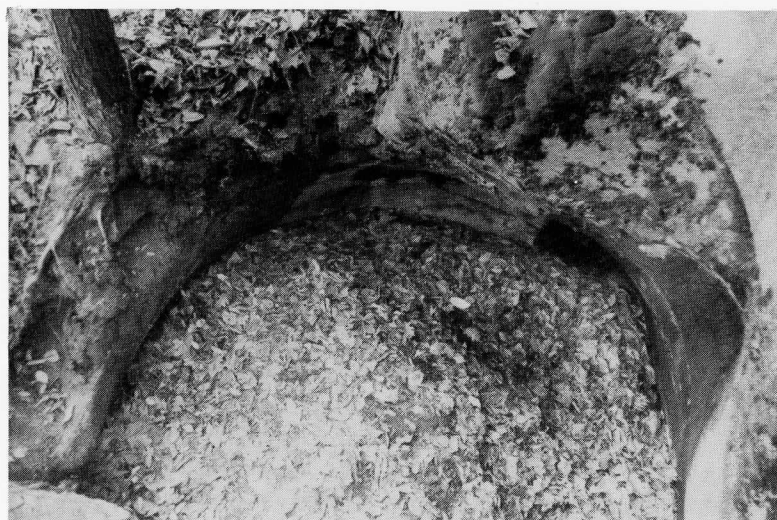
LITTLE PURGATORY CHASM POTHOLE

At the lower end of the Little Chasm or Little Purgatory two streams converge to form a pool. Overlooking the pool is a bedrock cliff and the vestiges of a large, smooth, symmetrical Pothole. Preliminary estimates of the hole size are: twenty five feet high (deep) by fifteen feet in diameter, (25' x 15').

Approaching the Purgatory Pothole it is seen in cross-section with one half missing - destroyed by ice movement? The remainder perfectly formed with smooth, polished curved surfaces.

Many generations of seasonal plant decay, leaf accumulation and surface drainage have left a thick deposit of humus in the bottom of the structure. Some boulders and roots may also be found from cave-ins and slide collapse.
