The Sutton Historical Society restoration project for Sutton Center Cemetery started in August of 2019 and was completed in July of 2022. All tolled 68 gravestones were repaired and reset. Below are before and after photos of three.

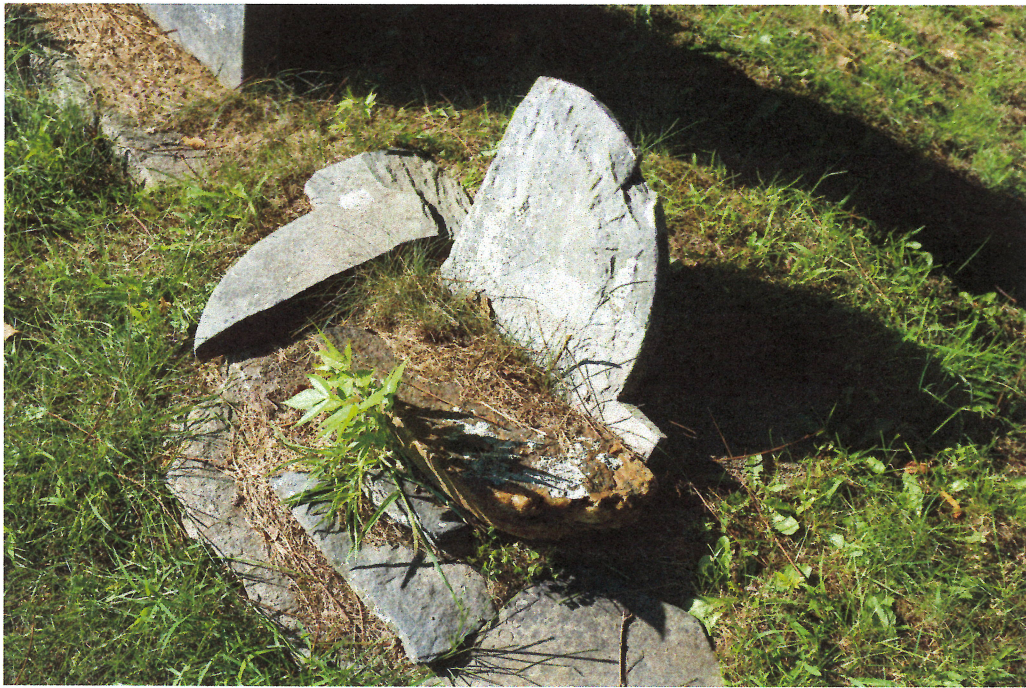
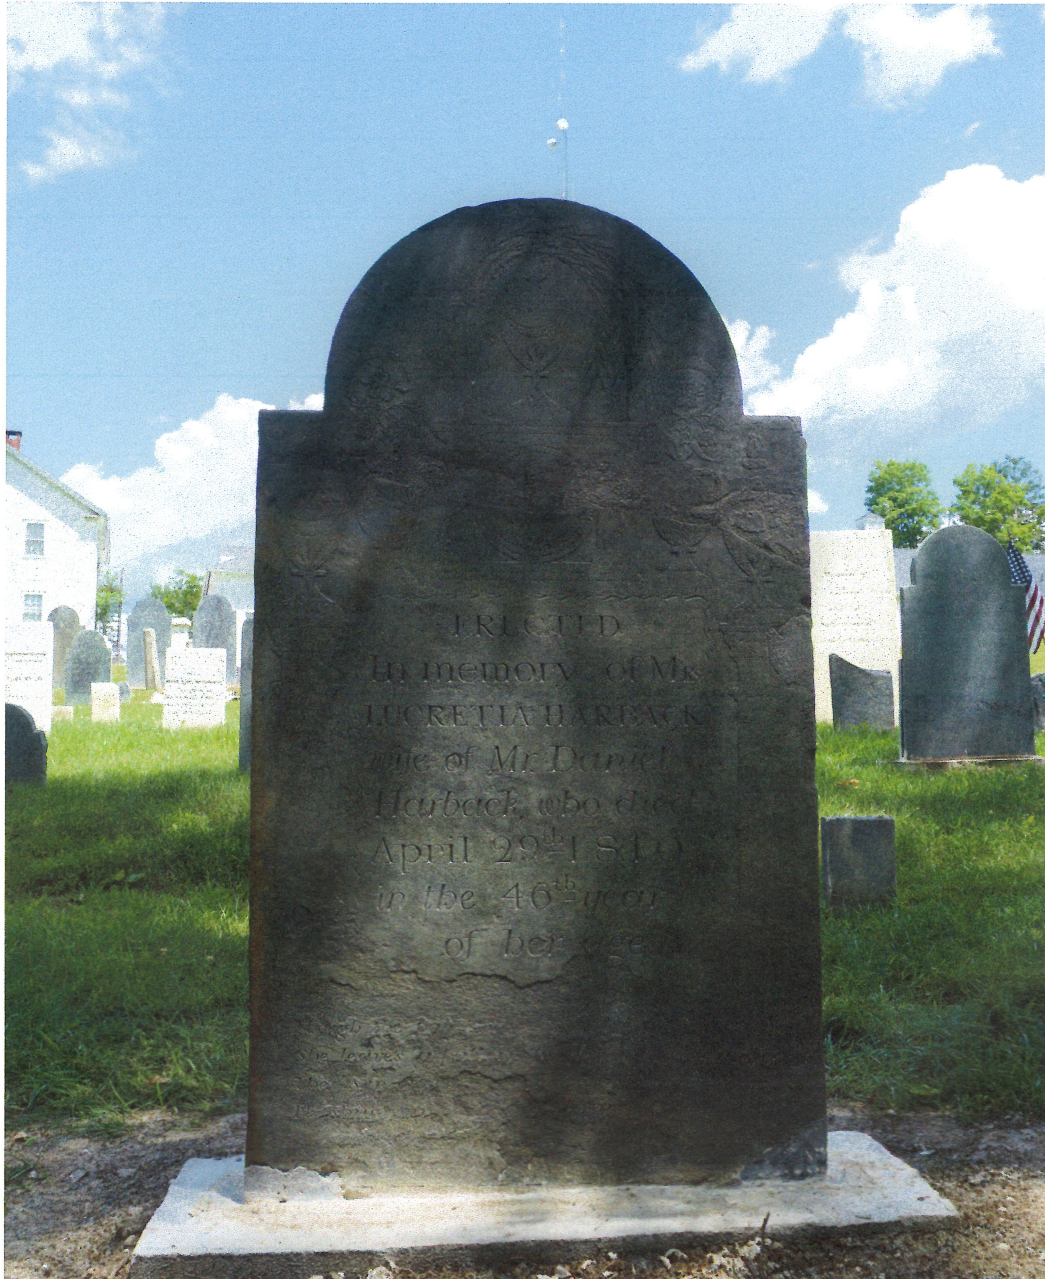
This gravestone for Sylvester Sibley was one of about a dozen that had been reassembled long ago - probably more than a century - using iron straps and bolts. As the bolts corroded, the expanding rust broke more of the stone. On the positive side, a hundred or more years later, the pieces were still there.
